COLUMBIA DAM

NJ 00124

**PHASE 1 INSPECTION REPORT
NATIONAL DAM SAFETY PROGRAM**

OVERVIEW
COLUMBIA DAM
13 December 1978

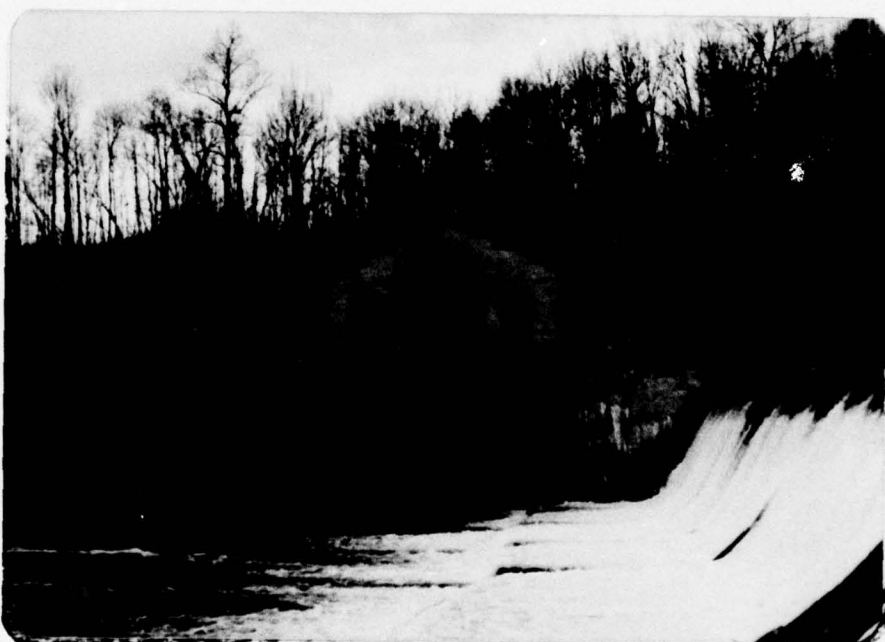
Abandoned Power House and spillway apron.
Looking west.

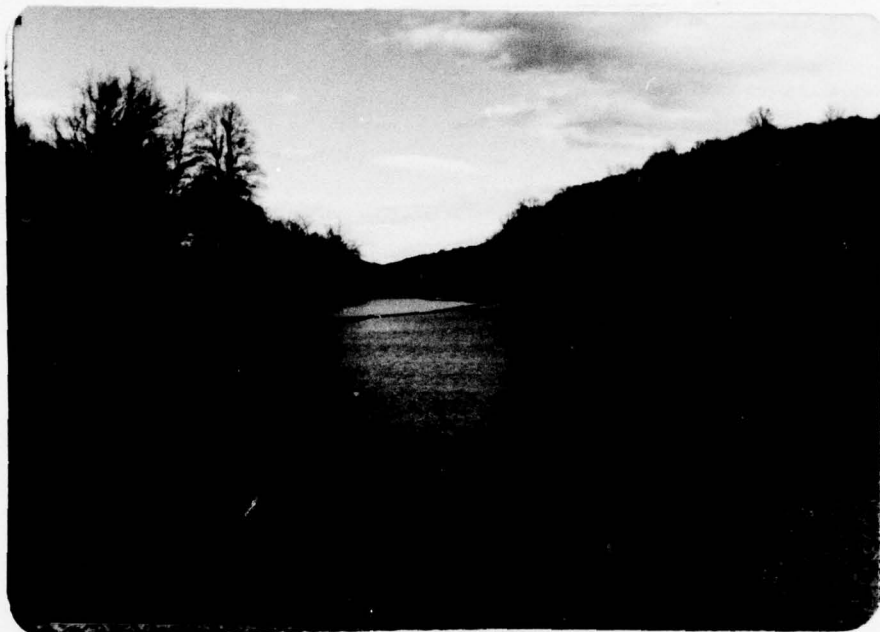
Paulinskill River. Looking upstream.

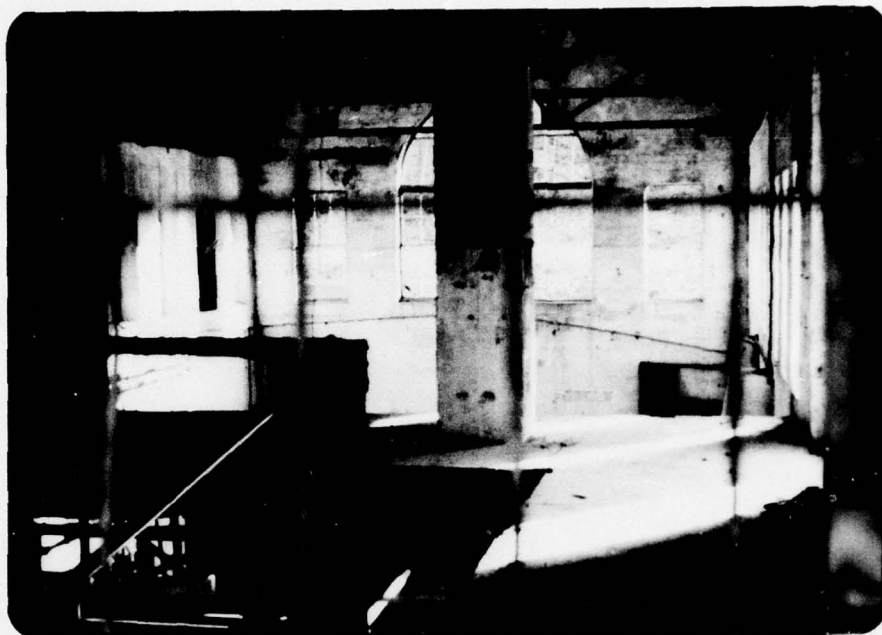
Interior of abandoned power house.

- (1) Repair cracks and deterioration of concrete of the power house at the right abutment of the dam and at the entrance and interior of the spillway at the left abutment.

(1) Repair cracks and deterioration of concrete of the power house at the right abutment of the dam and at the entrance and interior of the spillway at the left abutment.

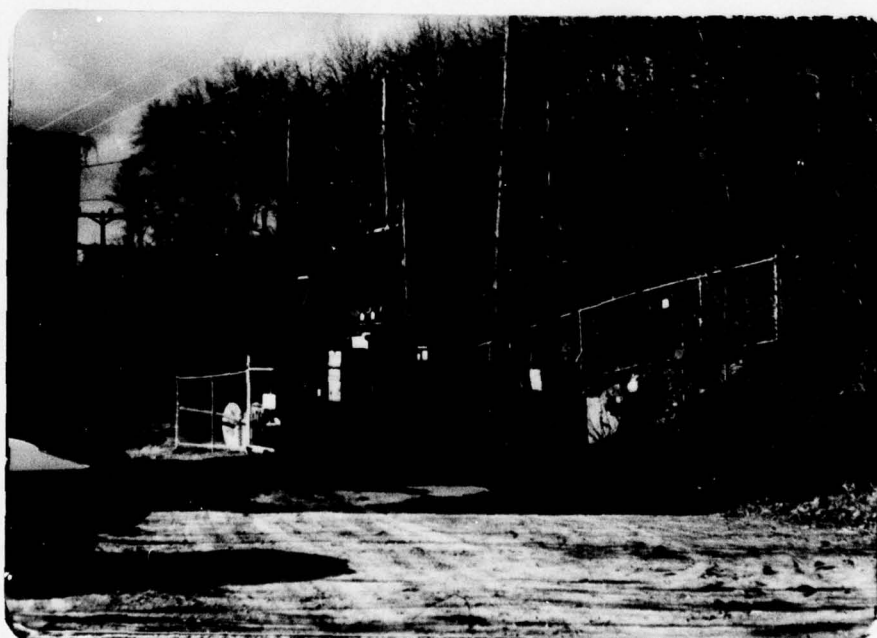
New Jersey Power & Light Company.
Columbia substation at right abutment.

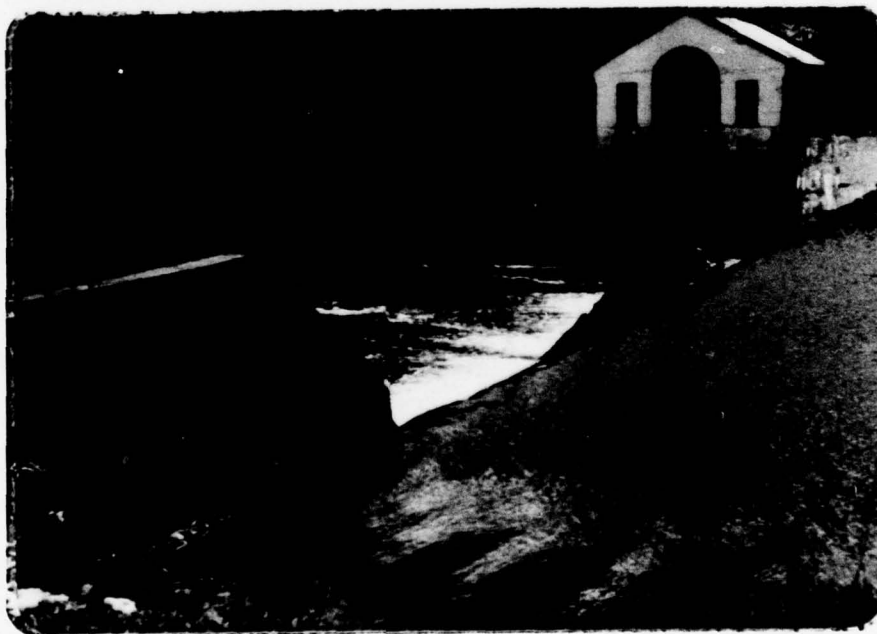
Tree trunk at top of spillway.
